FINAL REPORT
ACCIDENT TO
NOMAD N22R 9M-ATZ
KOTA KINABALU
6th JUNE, 1976

AIRCRAFT ACCIDENT
REPORT NO :1/76

AIRCRAFT TYPE & REGISTRATION: Nomad N22B, 9M-ATZ

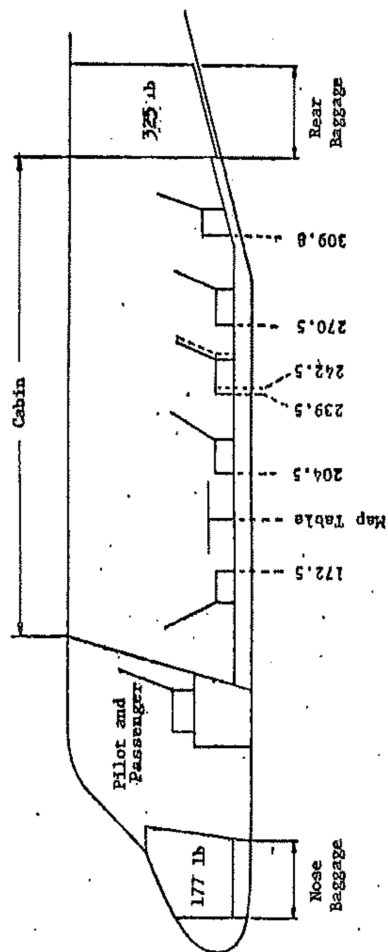
Fig. 1

So that paragraph 2.1 Analysis may be understood it is necessary to consider the position of the control column for the various phases of flight. The following cases are intended to illustrate the various conditions of flight experienced in a tabular form for ease of reference. The first column is intended to allow easy cross reference to the graph. Column three to six are intended to give the actual flight parameters assumed in arriving at the tailplane angles listed.

CASE	FLIGHT PHASE	C OF G POSITION % MAC	POWER PSI	AIRSPEED KTS	FLAP POSITION	TAILPLANE ANGLE	REMARKS
A	Take Off	43.60	90+	70	0 or 10	-0.04 or 1.1	Safe
B	Climb	43.60	90	100	0	1.57	Safe
C	Cruise	43.70	60	120+	0	1.76	Safe
D	Initial Approach	43.76	30	86	20	3.46	Moving towards forward stop
E	Final Approach	43.74	30	86	25	3.85	Almost on stop no margin for transient excursions

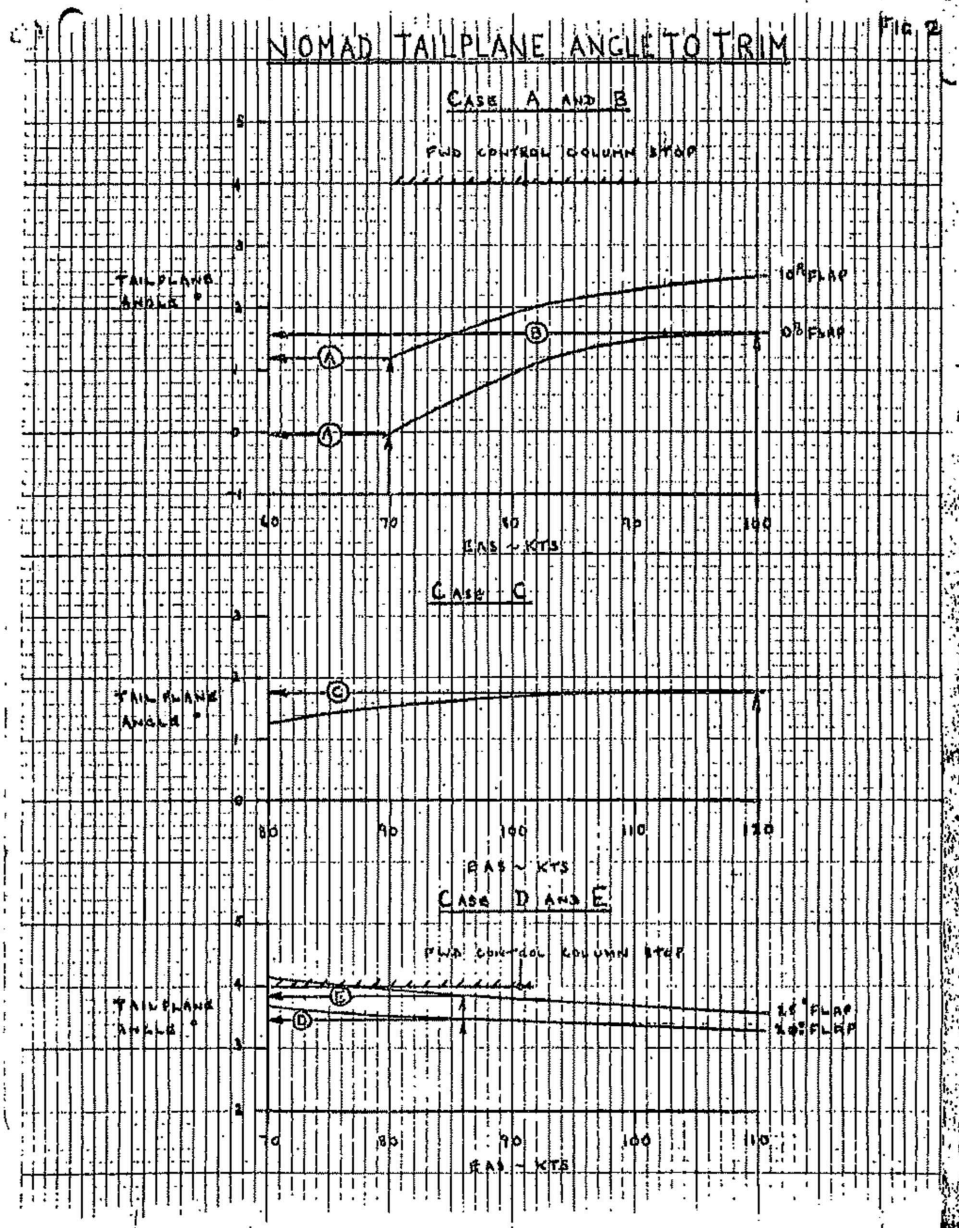
To consider the second question first it is necessary to study the implications of Fig. 2. From this figure it can be seen that the point of running out of forward control column movement is a function of four factors, namely centre of gravity position, flap position, power setting and to a lesser extent airspeed. The figure demonstrates that as flaps are lowered the tailplane incidence is increased (control column moving forward) significantly with the worst case at 25° of flap. Also clear is that when both power is increased or centre of gravity moves aft the tailplane incidence is again increased. By comparing Cases A, B, C, D and E which cover the various phases of the fatal flight it becomes clear why the aircraft was able to complete the earlier part of the flight without loss of control.

Therefore it can be seen that the flight could be carried out successfully up to the approach phase where it can be seen that the control column is moving towards the forward stop in the initial approach and probably reached the forward stop when an attempt was made to check the nose pitch up as the flaps were passing 25° with power set about 30 psi.
