Proposed Reclamation and Capital Dredging for the Sunrise City Mixed Development at Mukim Kuala Nerus, District of Kuala Nerus, Terengganu, Malaysia

Environmental Impact Assessment

Baseline Report

Project No.	62801461			
Project Title	Proposed Reclamation and Capital Dredging for the Sunrise City Mixed Development at Mukim Kuala Nerus, District of Kuala Nerus, Terengganu, Malaysia			
Subject	Baseline Survey Report			
Client	Elcca Properties Sdn. Bhd.			
Project Director	Mark Oliver			
Project Manager	Syed Mohazri Syed Hazari			
Document No.	62801461-RPT-103 Rev 03

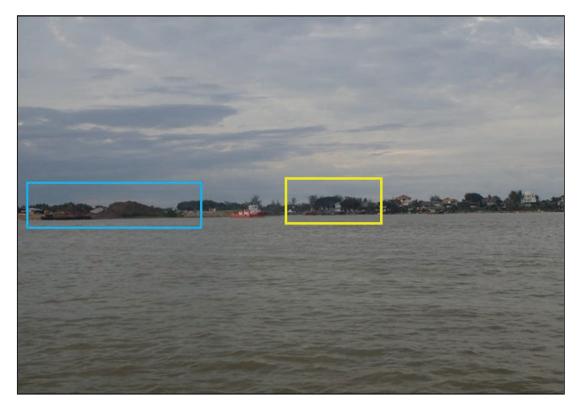
Photo 2.2 Ship repair facilities (yellow box) and earthwork activities (blue box) were observed along the shoreline

Station	Observation		
WQ1	• Turbid water.		
	• Oil sheen was observed during spring ebb tide sampling (Photo 2.1).		
	• Ship repair facility and earthworks were observed at the shoreline approximately 200 m from this station (Photo 2.2).		
	 Vessels were anchored around this station during neap ebb tide sampling (Photo 2.3). 		
WQ2	Turbid water.		
	 Rock revetment was observed along the shoreline near to this station (Photo 2.5). 		
	• Approximately 100 m from the river mouth (Photo 2.4).		
	Oil sheen was observed during spring ebb tide sampling		
WQ3	Turbid water (Photo 2.6).		
	Rough sea condition.		
	• Located approximately 1 km from the Sg. Terengganu river mouth (Photo 2.7).		
WQ4	Clear water.		
	• Located approximately 500 m from the breakwater at Seberang Takir side (Photo 2.8).		
WQ5	Clear water (Photo 2.9).

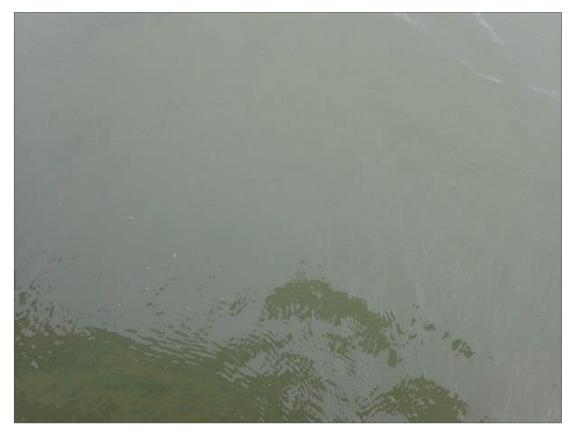
Photo 2.6 Turbid water at Station WQ3

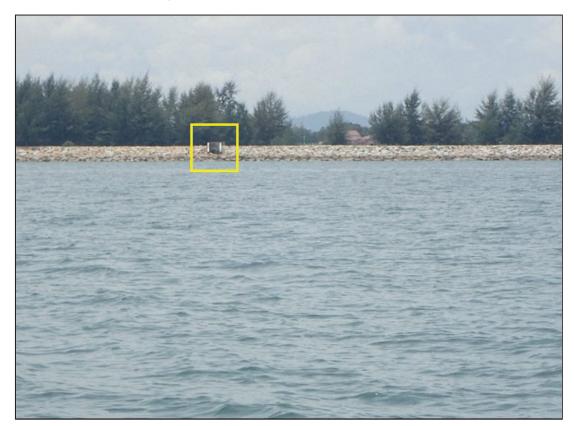
Photo 2.11 Discharge outlet approximately 1 km from Station WQ7 (yellow box)
