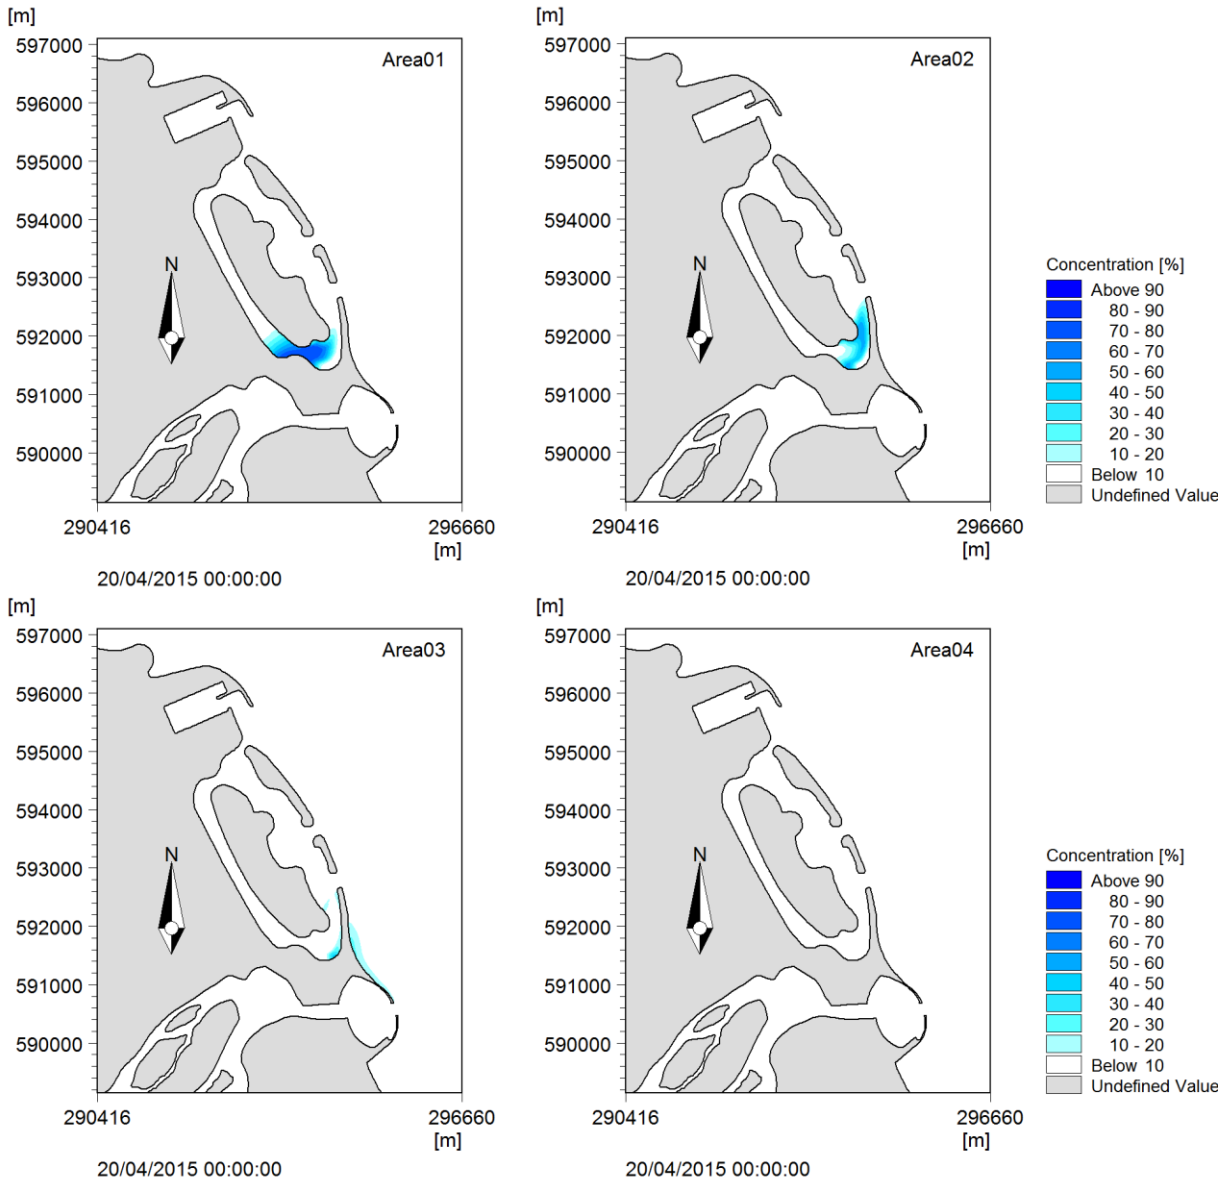
Figure 3.3 Layout 1 flushing – Day 2

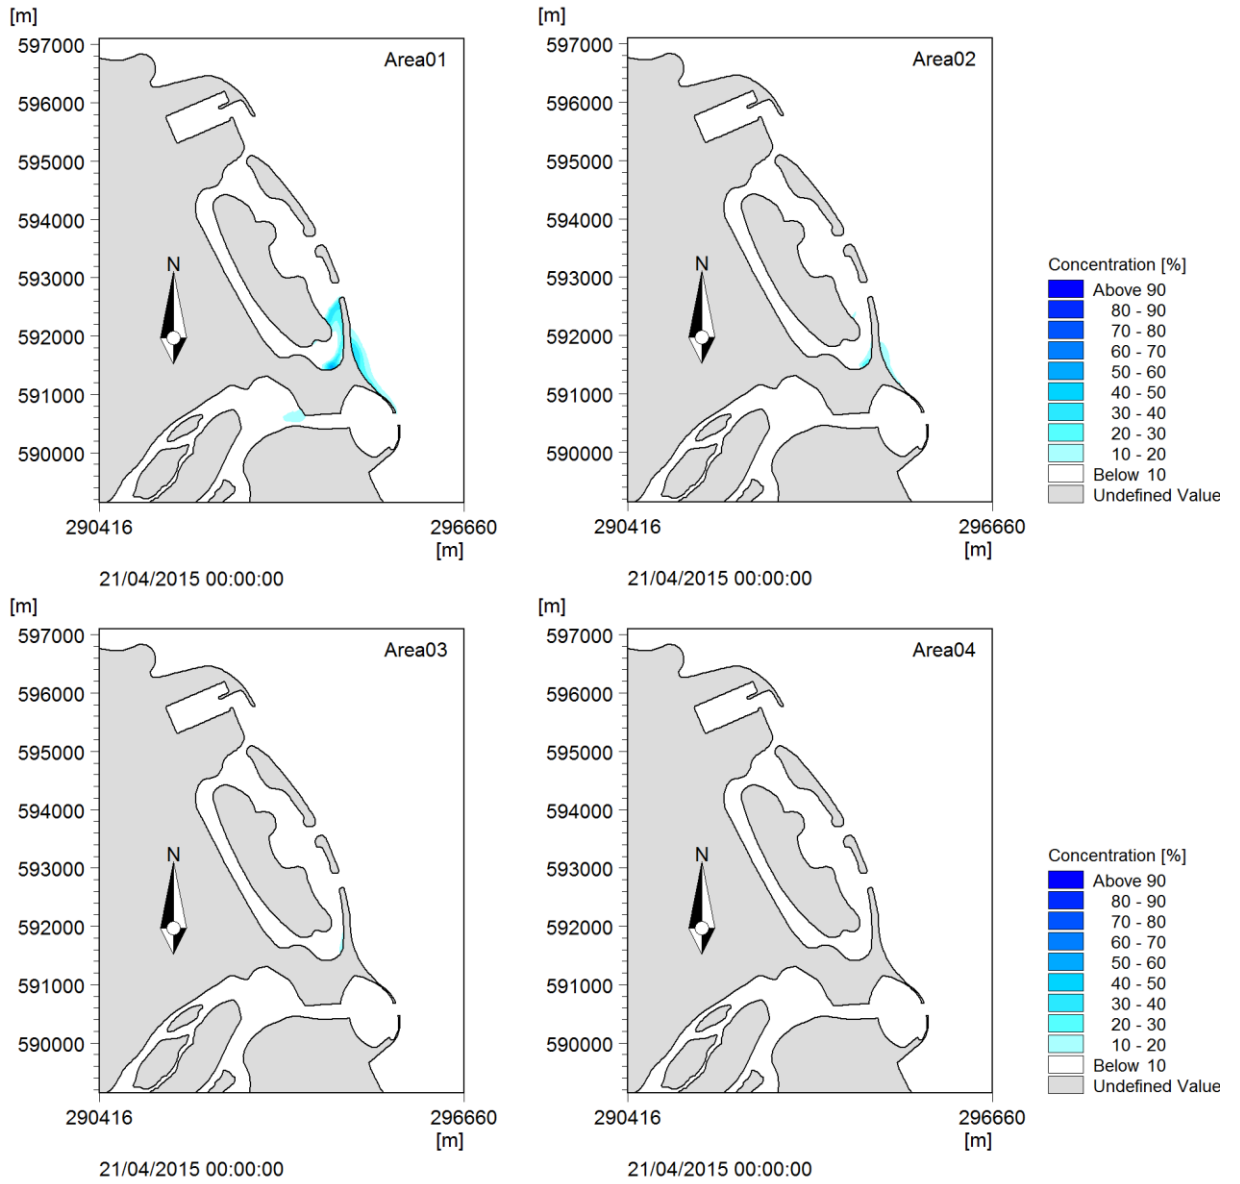
Figure 3.4 Layout 1 flushing – Day 3

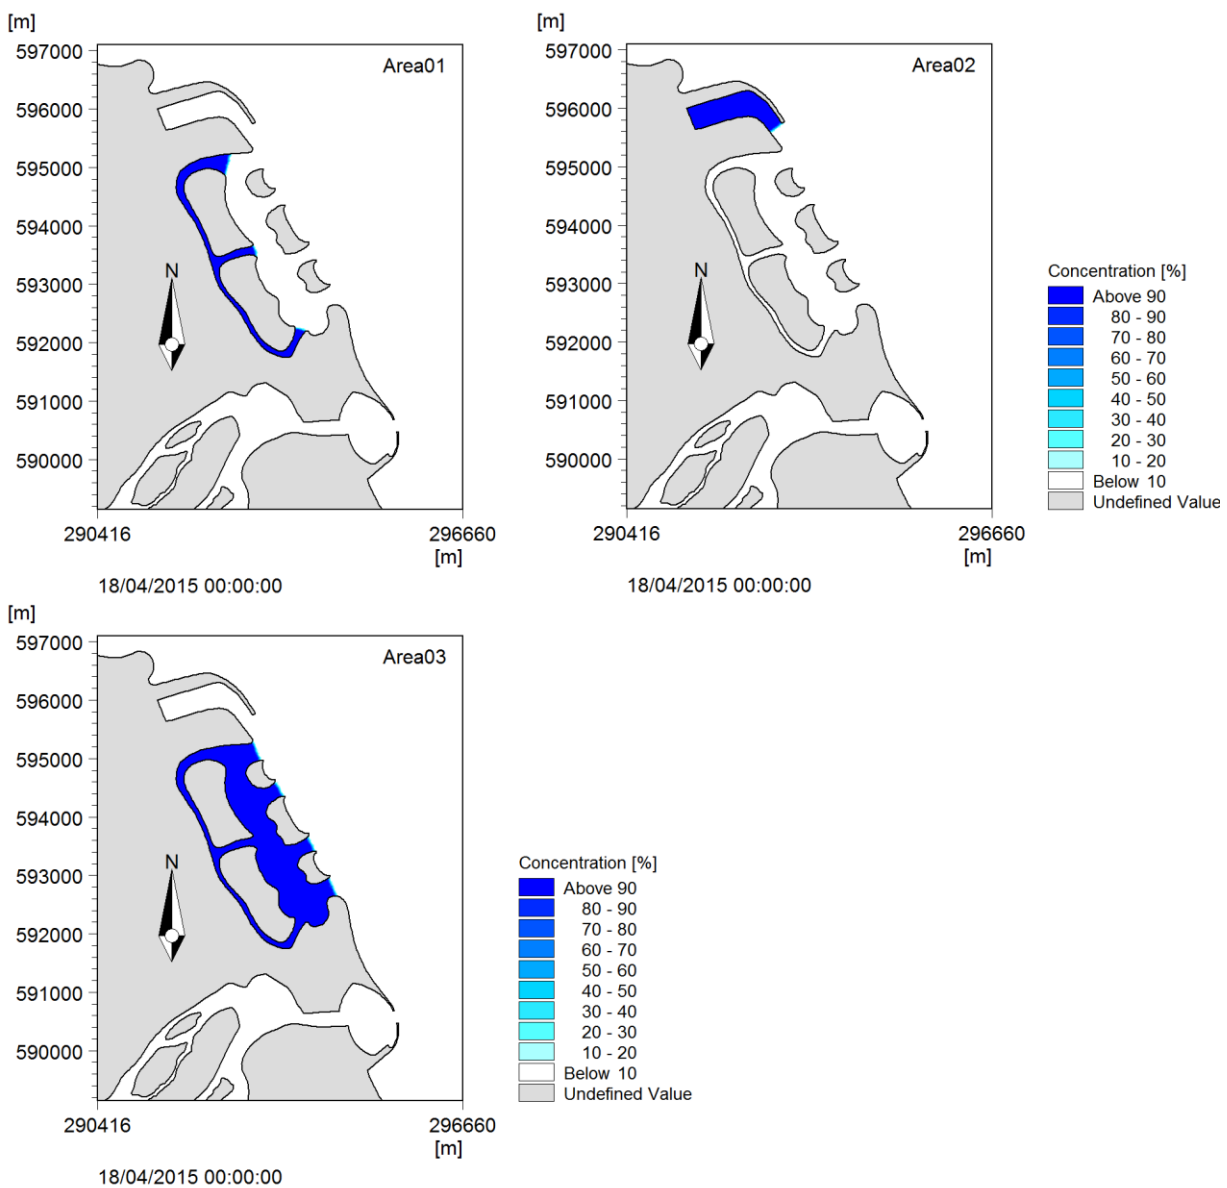
Figure 3.13 Layout 4 flushing – Day 0

A conservative tracer was placed in three locations for Layout 4 as shown in Figure 3.13, with the concentrations after 1, 2 and 3 days being shown in Figure 3.14 to Figure 3.16. These are intended to assess:

- 1 The flushing of the inner channel between the reclamation areas.
- 2 The flushing of the basin for the Cruise Terminal and ship repair area.
- 3 Flushing of the larger area behind the offshore islands.

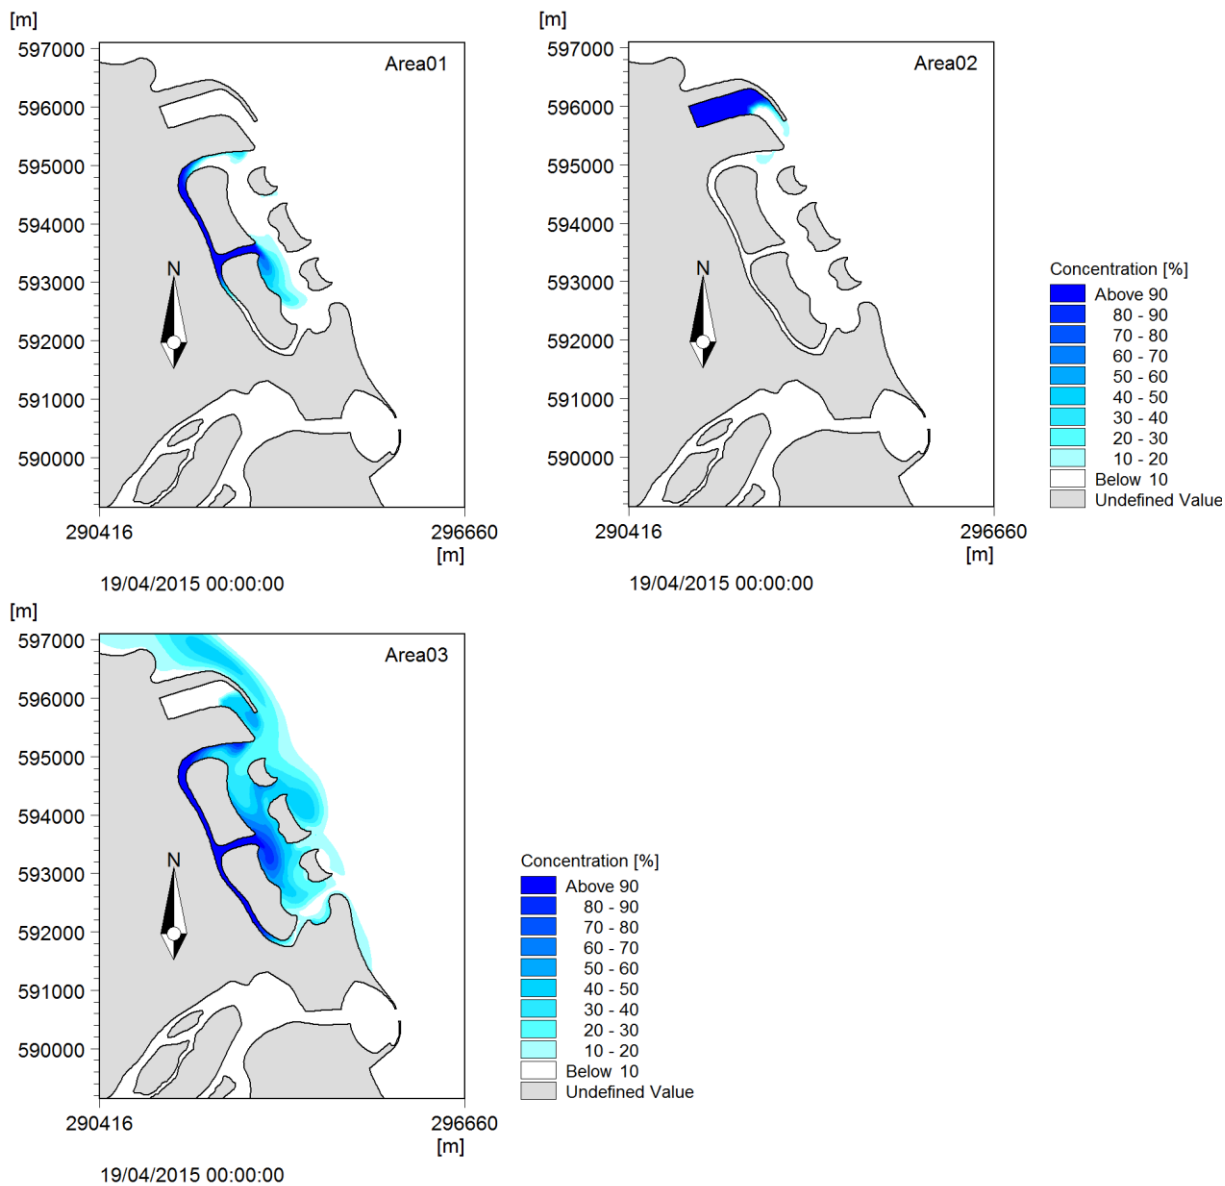
Figure 3.14 Layout 4 flushing – Day 1

In this layout the dimensions of the inner channel have been reduced and this has led to a reduction in the flushing capacity of the inner channel leading to possible water quality issues in this areas. The water quality in the vicinity of the ship repair facility is unchanged from Layout 3.
